June 2019

**Innovative geospatial
applications: integration
of geospatial data for
retaining wall management**

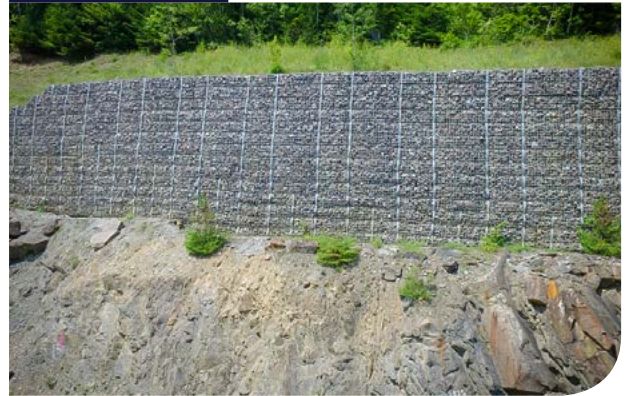
Figure 1

The wall was constructed in 1999 along Route 17 a few kilometres south-east of Campbellton, New Brunswick, Canada. It is approximately 20m high and 300m long (see Figures 1 and 2).

The retaining wall

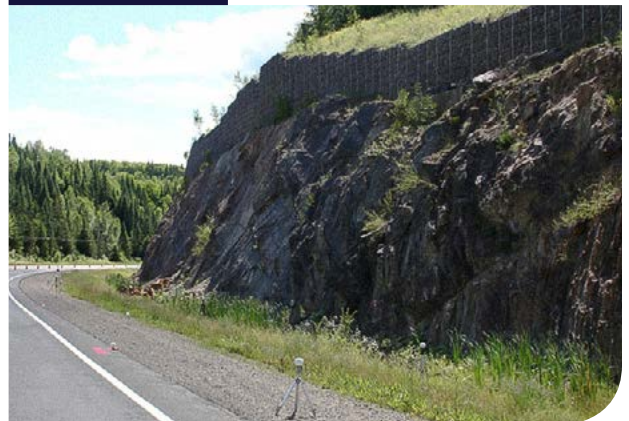
Figure 2

The retaining wall and rock face

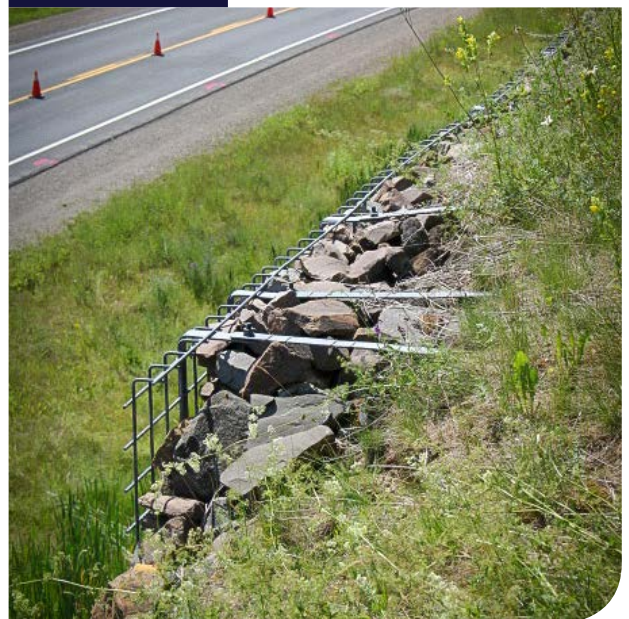
Figure 3

The wall is constructed from stone facing covered by restrained wire mesh (see Figure 3). These are not gabions (wire cages filled with rock) which are more stable. No surveys of the wall were conducted at the time of construction, although construction diagrams were available. The wall is built on a rock base that was blasted to enable the road to be constructed. At the rock base/wall interface there should be a 1.5m bench (see Figure 4).

Stone facing and wire mesh

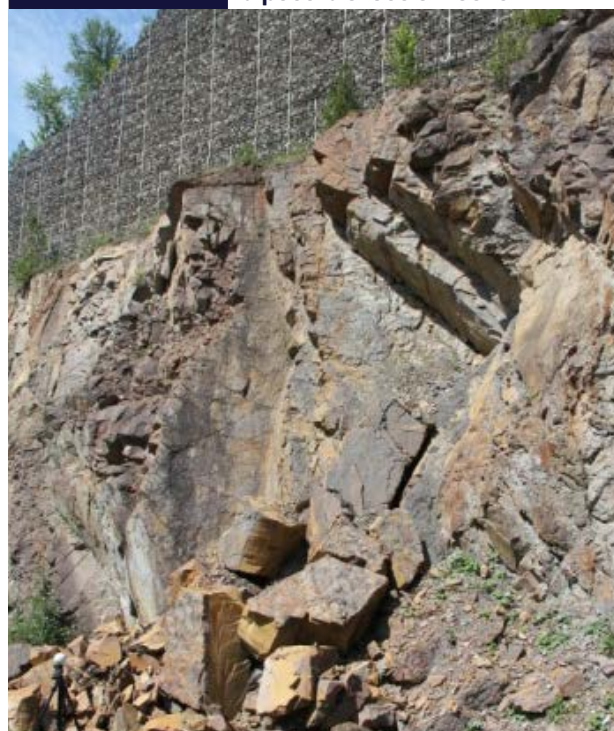
Figure 5 Areas where there has been a possible loss of rocks

The above statements are important as they indicate there is no record of the condition of the wall immediately after construction in 1999. There is no record of the how well the stone facing was placed and covered by the wire mesh. There may have been places with too few stones; there may have been places where the wire mesh was sagging under the weight of the stones and where rocks were actually hanging from the wire mesh. In some places there are rocks at the base of the wall which may have fallen from the wire mesh since construction, or may have fallen there during construction (see Figure 5). In addition, there are places where the bench is 1.5m and others where there is no bench. Again, as there was no as-built survey carried out, it is impossible to tell if the variations in the size of the bench were created during the original construction or are the result of changes to the structure over the decades since construction. Finally, there are cracks in the rock face – regretfully there is no information regarding how long the cracks have been there. There is evidence to indicate that some repairs to the wall have taken place since its construction in 1999; there are areas where significant amounts of concrete have been applied to the rock base. However, it is not possible to determine when this was carried out.

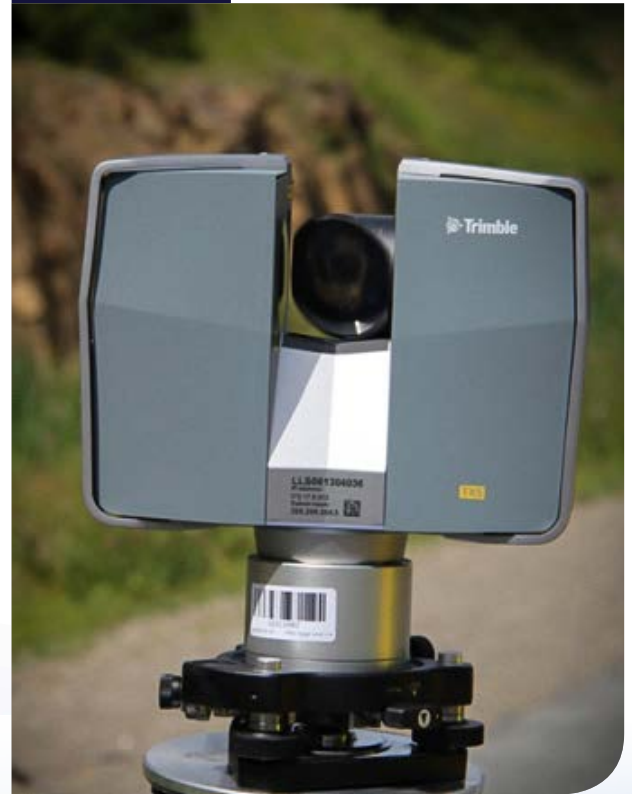
Figure 7

UNB proposed a solution based upon TLS utilising multiple scans of the wall. A Trimble TX5 laser scanner (also known as the Faro Focus 3D scanner; see Figure 7) was used and the scans were registered utilising spheres visible in adjacent scans. An accuracy assessment of the scan was also carried out; NBDTI marked a number of points along the edge of the road coordinated by Real-Time Kinematic GPS (RTK GPS). These points were also scanned, allowing the wall scans to be attached to the provincial coordinate system.

Trimble TX5 laser scanner

The Trimble TX5 Laser Scanner has an accuracy of a few millimetres, while the UAV has an accuracy of a few centimetres. The research team therefore attempted to avoid having large overlapping areas of the laser scanner data with the lower accuracy UAV data, which is a possibility when the datasets of the same subject area are integrated.

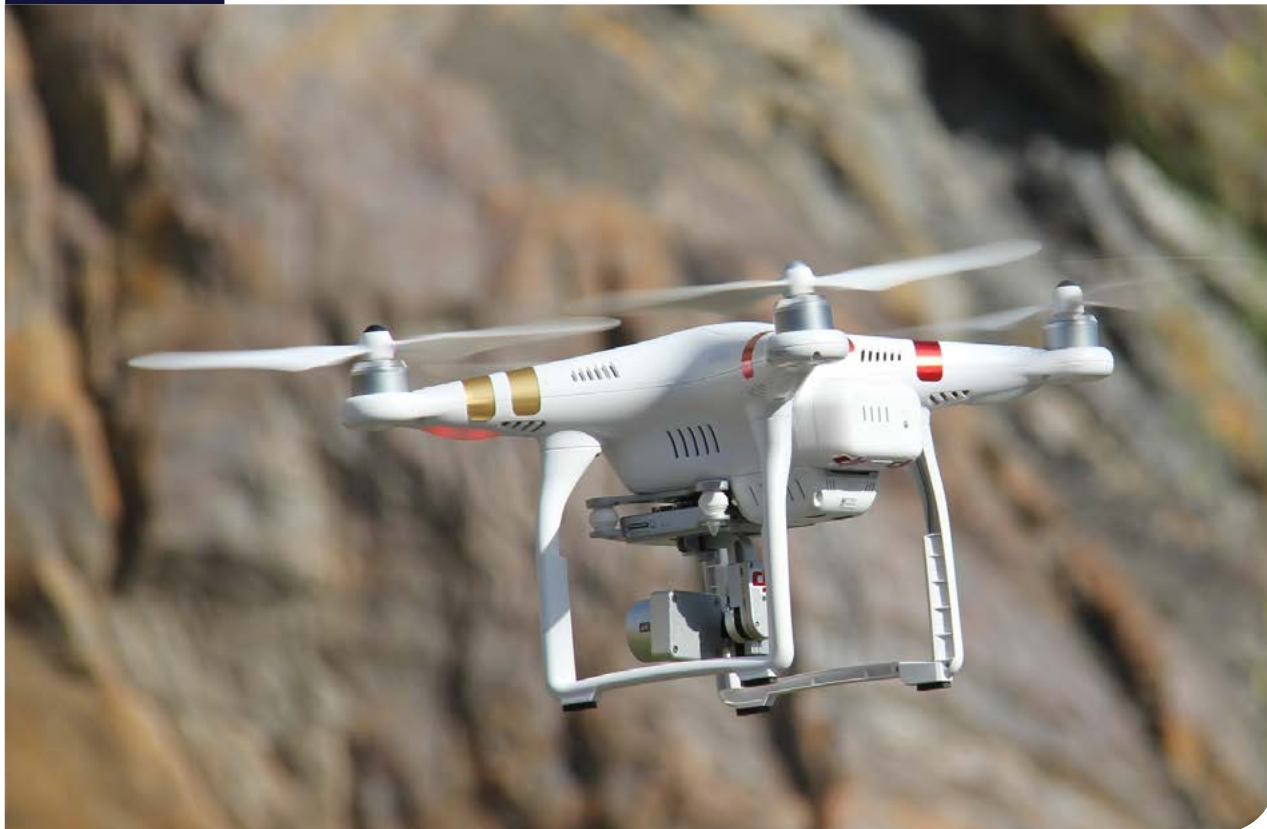
Figure 12

DJI Phantom 3 UAV

The NBDTI used a DJI Phantom 3 Professional UAV (see Figure 12). This has a built in 4K camera which is mounted on a three axis (pitch, roll, yaw) gimbal stabiliser so that it is able to record with a constant heading. It also takes 12.76 megapixel images. The UAV has a vertical accuracy of $\pm 0.5\text{m}$ and a horizontal accuracy of $\pm 1.5\text{m}$ (DJI, 2018). The UAV is controlled through an app on a mobile phone, and the battery provides 15-20 minutes of flying time with a one-hour recharge time. The UAV is able to take both still pictures and movies. For the purposes of this research, photo overlaps were used to enable the images to be stitched together. To process the UAV data, Pix 4D was used.

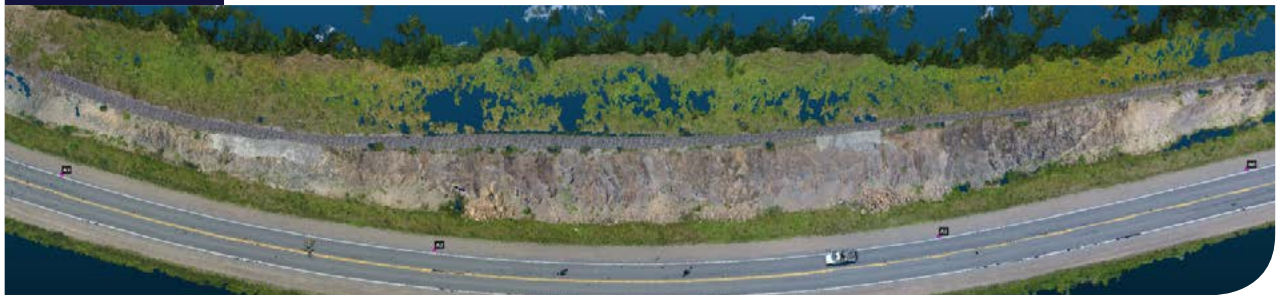
Figure 16 represents the fully registered point cloud of the retaining wall resulting from the UAV. The viewing angle is different to the laser scanner, but the quality of the registered point clouds were confirmed to be a few centimetres when a comparison was made with the GPS control points (the laser scanner precision was 16mm).

Figure 16 UAV point cloud of entire wall

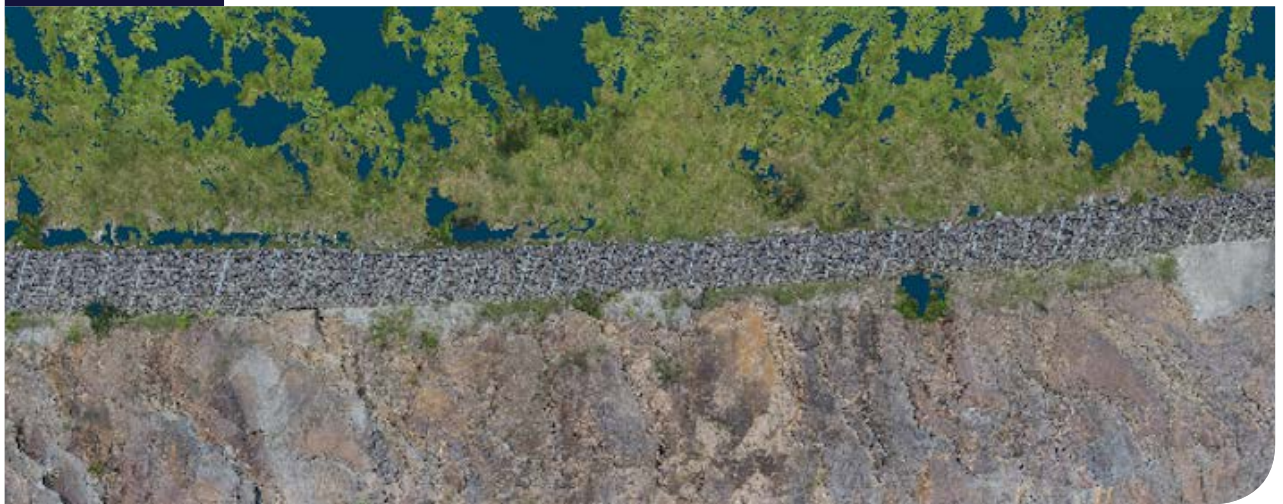
Figure 17 is an enlargement of a small area of Figure 16. Some blue areas can be still seen, but most of the blue areas where the laser scanner could not record were covered by the UAV. This is the data that can be used for integration into the TLS data.

Figure 17 Enlarged area of UAV point cloud

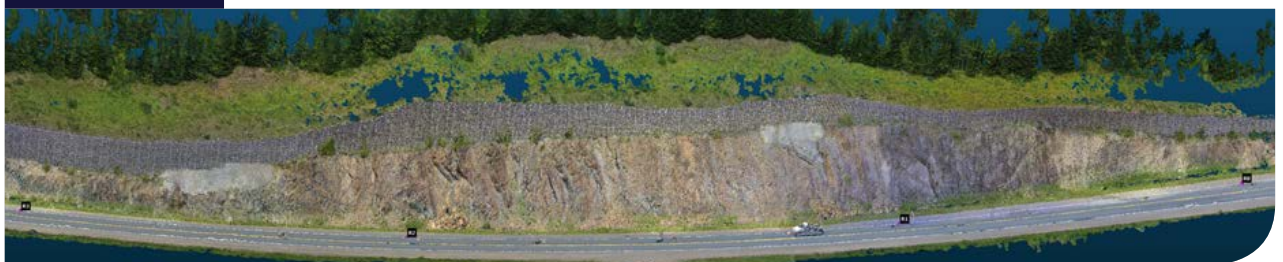
Figure 18 Location of the four control points

Figure 18 illustrates the location of the four control points chosen from within the UAV and laser scanning point clouds.

Table 2 shows the difference (labelled 'Error') at the control points (labelled 'R0' to 'R3') between the coordinates determined by the laser scanner and the UAV. For the calculation and integration, the CloudCompare software was used. The maximum difference was just over 7cm while the smallest difference was just over 3cm.

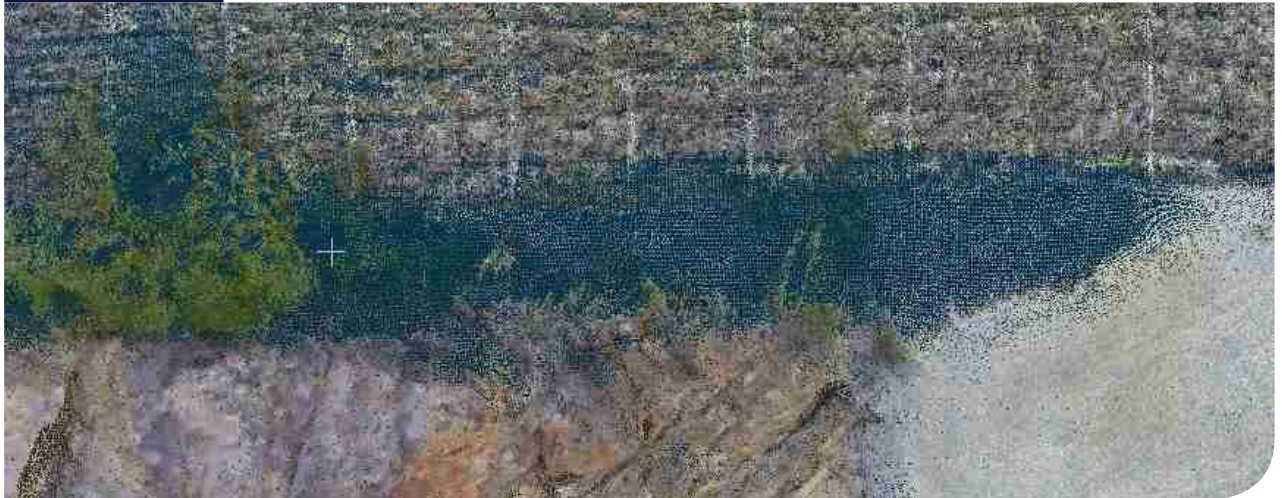
Figure 19 represents the same enlarged area shown in Figure 15 but with the merged UAV data. Data points in the blue area within the rectangle are now visible. Figure 20 shows the entire integrated point clouds based upon both the laser scanning and UAV point clouds.

Figure 19 Enlarged image of merged point clouds

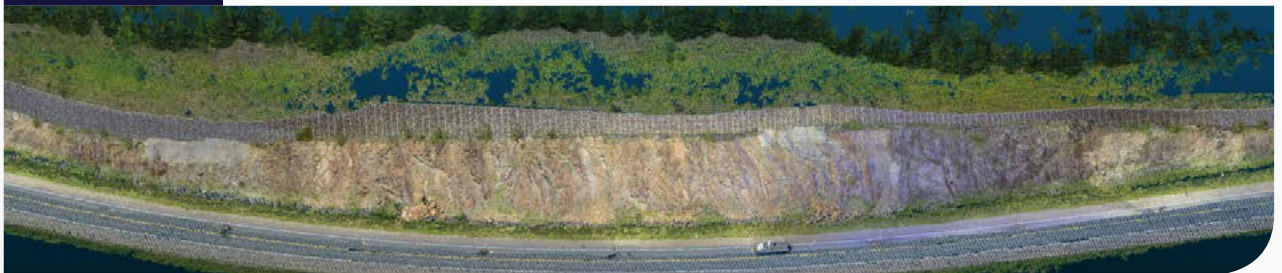
Figure 20 Merged point clouds
